# PUBLIC WORKS DEPARTMENT NEWS

## WHAT'S WRONG WITH THESE PICTURES?

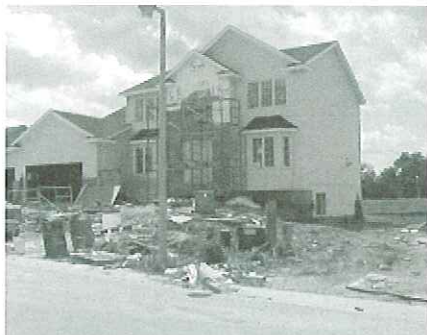
1

**CORRECT ANSWERS:** 1) No dumpster or litter control is in use. 2) Perimeter silt fence has been breached by a subcontractor. 3) Internal soil erosion is not addressed with silt fence, bio-log, mulch, or vegetative cover. 4) Storm sewer inlets are not protected against receiving sediment. 5) There is no perimeter silt fence on the down-slope, exposing the pond to sediment loss. Unattended stockpiles must have perimeter ESC and be seeded. 6) There is not a stabilized vehicle entrance (SVE) installed for the site, causing street tracking. 7) The stockpile alters the approved drainage grade, interfering with proper storm water flow. 8) A subcontractor has dumped dirt in the right-of-way, there is no perimeter ESC, and the stockpiles are unprotected. In cases 1-8, rain storms will eventually move garbage and sediment to the river, contaminating our water - all are violations that can lead to a Stop Work Order. 9) NOTHING IS WRONG! Perimeter ESC is in place, the SVE is installed and used, and there is no unmanaged litter or construction debris. This site gets an A+! If it is yours, thanks for "Keeping it Clean!"
